Structural Evaluation of Riveted Spillway Gates

Final report

Prepared for U.S. Army Corps of Engineers
Washington, DC 20314-1000

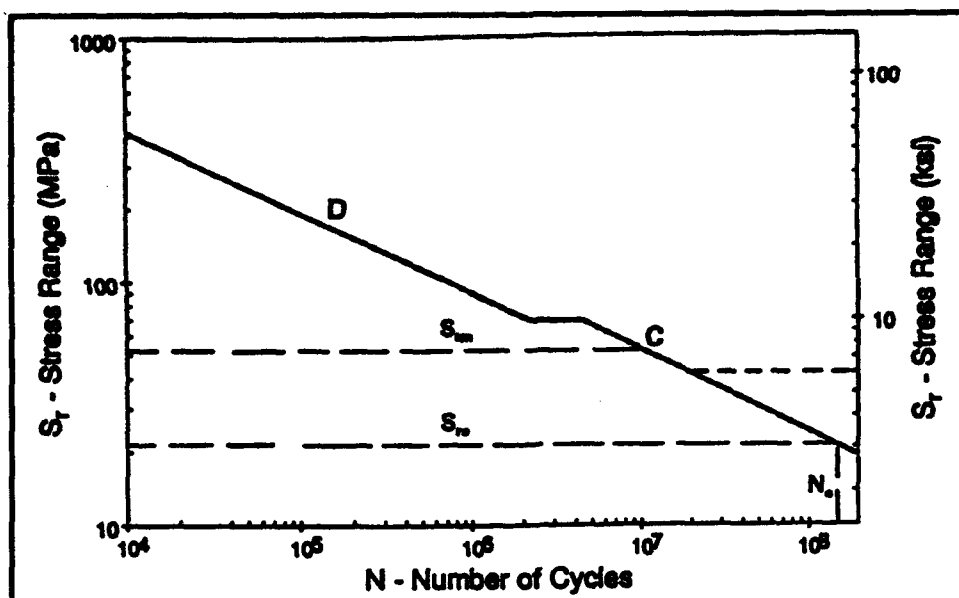
Figure 31. Estimation of fatigue life of riveted spillway gates members

Figure 31 demonstrates the procedure of estimating the fatigue life, N_e , of a riveted spillway gate member which is subjected to variable-amplitude stress ranges represented by Figure 29. In this case, the highest stress range, S_{rm} , in the stress-range histogram is greater than 6 ksi, the assumed fatigue limit; eventual fatigue damage may occur. The estimated fatigue life is obtained by locating the intersection of the equivalent stress range, S_{re} , and the extension of the Category C line, as shown in Figure 31 (Keating and Fisher 1989; Fisher et al. 1987).

At the detail to be evaluated, S_{rm} and S_{re} are the highest stress ranges and the equivalent constant-amplitude stress range, respectively.
